The devil's in the detail

A review of key metal roof system elements and their associated guarantees leaves the question: Are clients getting the warranties and long-term performance that they are paying for? In this article, Richard Polling addresses the holistic design of metal roof systems and important implications for the long-term performance of insulated roof systems.

*Article by: Richard Polling, Group Director - MRC Group South Africa
Photographs courtesy of MRC Group.*

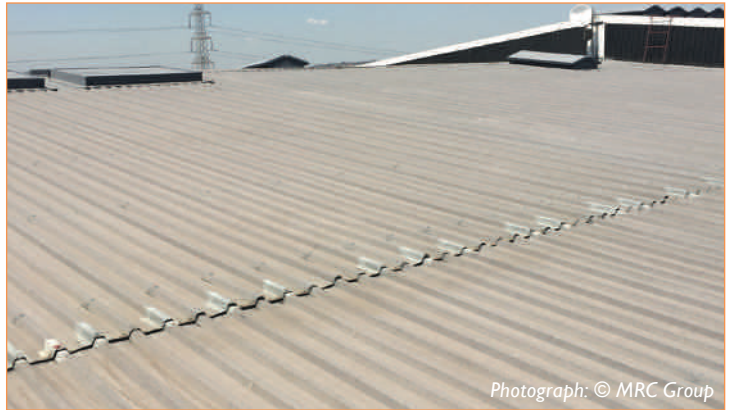
Failed open end lap, allowing the ingress of wind-driven rain.

- **Roof sheet end laps and side laps:** It is considered best practice to install butyl seal type sealants to both the side laps and end laps of pierced fix roof systems, and essential for roof pitches below 7.5 degrees. Should water ingress occur through these joints, it is because it is not common practice to include these sealants. When a leak in the lap is discovered during the operational life of the roof, it is common practice to seal the joint from the exterior with a waterproofing membrane; however, the water vapour now encapsulated within the joint forms a more corrosive environment as it warms up and cools down, thereby speeding up the corrosion process on the end lap of the roof sheet, causing more leaks and now making the roof sheet dangerous to transverse during maintenance.

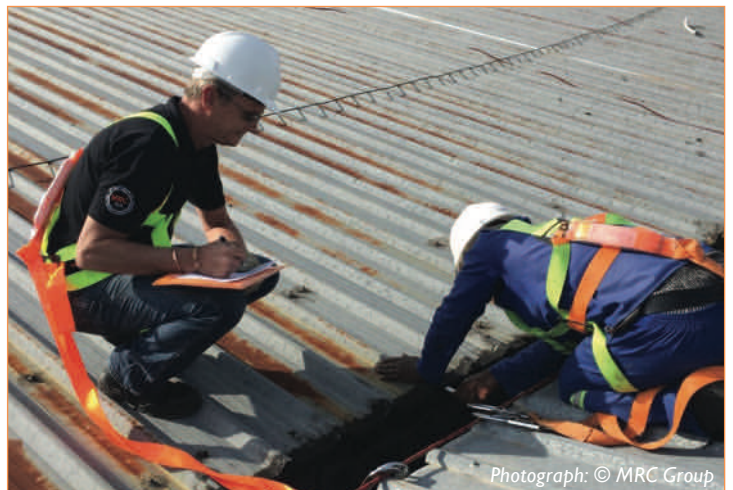
Essential recorded maintenance of the roof system.

To ensure the validity of the insulation's guarantee as well as its long-term performance, a recorded maintenance scheme (such as the Guardian™ Maintenance Scheme offered by MRC Group) needs to be in place for the complete roof system.

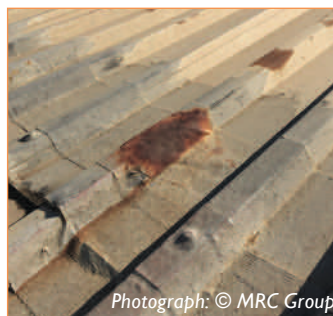
Breakdown of the end lap from rust under the waterproofing.

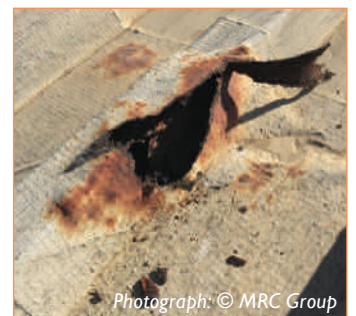
Water vapour sealed within the end lap by the waterproofing has accelerated the corrosion process.

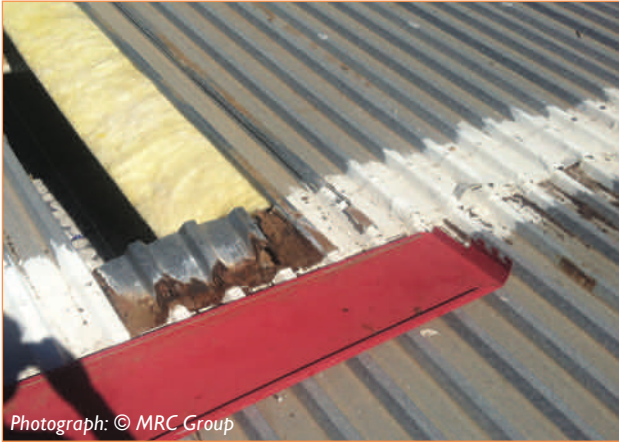
The corrosion process between roof sheets without butyl seal type sealants.

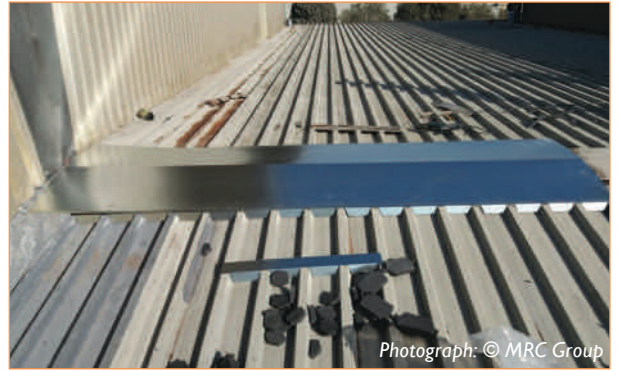
Photograph: © MRC Group
Due to the low roof pitch 925mm girth metal ridge flashing complete with serrated closures, polyclosures, sealants and turn-ups in lieu of the standard 462mm girth metal ridge flashing.

Example: A roof with a low roof pitch should have a larger girth ridge flashing, and therefore a thicker gauge of metal. This is to stop the impact of wind-driven rain, which can be a big contributor to water ingress into low-pitch roofs.

Many of the metal flashings installed around roof details have a girth of 462mm, for no technical reason other than the fact that two flashings can be made from a single 925mm-wide flat sheet, keeping waste and costs to a minimum – with no consideration given to long-term performance.

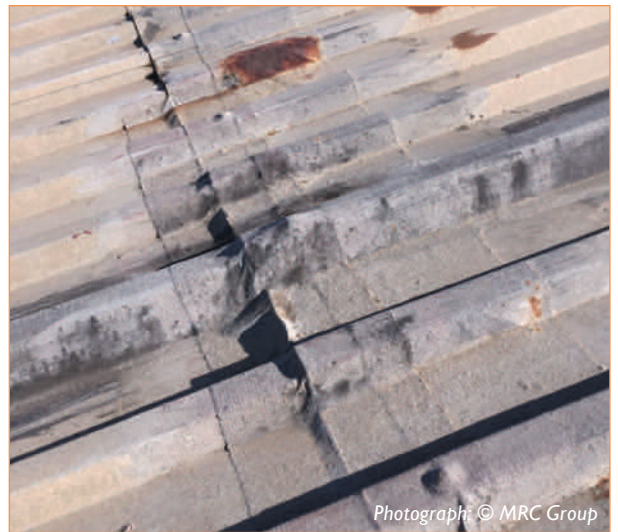
Photograph: © MRC Group
Standard waterproofing solution to water leaking through the end lap.

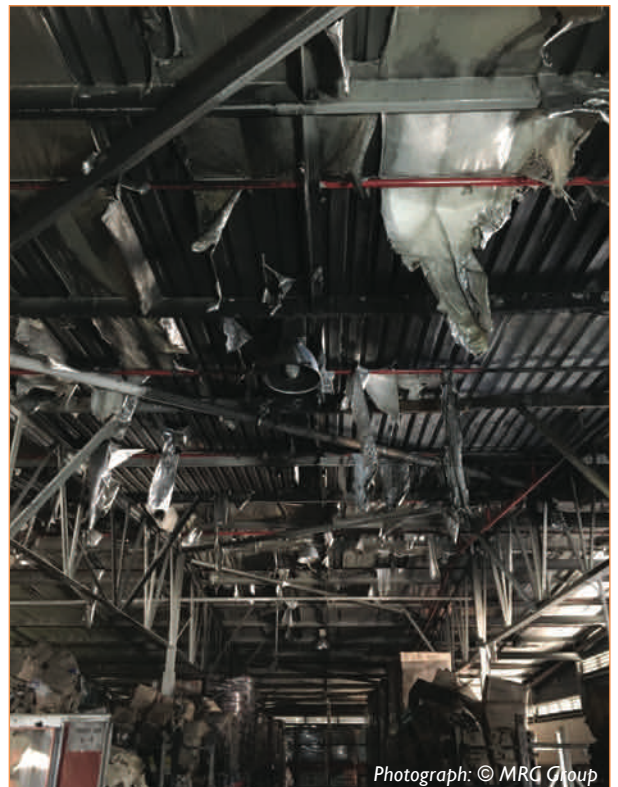
Photograph: © MRC Group
Fire damaged building. Was the insulation guarantee valid?

Meeting all the above conditions is vital in order to keep the validity of the installed insulation guarantee, and yet many roofs leak – thereby invalidating this guarantee. The impact on the thermal and acoustic performance of the insulation from water ingress may not be felt for many years; however, the fire performance may be impaired when you most need it.
