The devil's in the detail – part 2

In this article, we address the holistic design of metal roof systems and important implications for the long-term performance of insulation systems.

By Richard Polling
All images courtesy of MRC Group

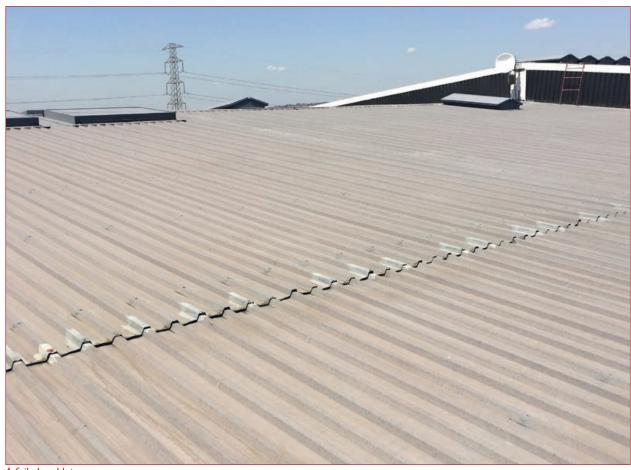
A failed end lap.

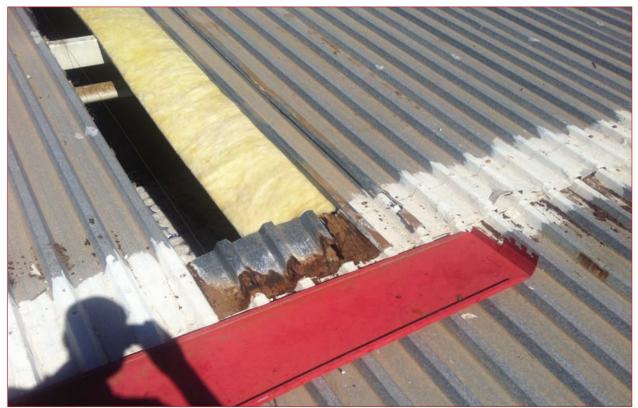
A rusty end lap.

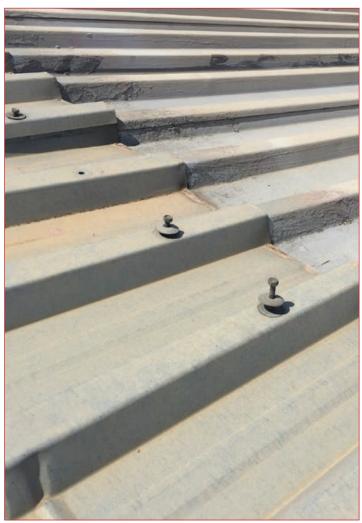
Loose screws, due to thermal expansion.

With such extreme temperatures and thermal movement it is no surprise that over time, the exposed fixings used in a pierced fix metal roof system can work themselves loose, rising up with the washer from the face of the roof sheeting. Although installing the fixings at the crown of the roof sheet mitigates this risk, there is still a risk of water ingress that ultimately makes any insulation guarantee invalid.

Regular recorded maintenance should include correct tightening of the exposed fixings throughout the whole roof ensuring that the washer is in good contact with the roof sheeting therefore ensuring there are no water leaks.
